Accident frequency rate (AFR) period 03 - target audience: all staff

Event learning – target audience: all staff

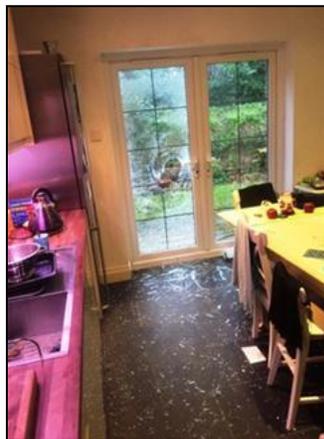
On the morning of Thursday 26 March a lineside fire was reported between Weybridge and Walton on Thames. Initial investigations indicate re-railing had taken place overnight in the area. Following completion of the works welding equipment was left track-side (although not close to the line) covered by a tarpaulin.

Underneath the tarpaulin were generators, igniters, propane and oxygen cylinders which were stored on their side. The fire caused the gas cylinders to explode with sufficient force to propel the oxygen cylinder 150 metres, over a lineside neighbour's house. A trolley wheel was propelled through the french window of the house into their kitchen. While NR is investigating the causes of this incident

- ✦ What fire risks exist in your workplace?
- ✦ What can you do to better manage these risks?
- ✦ How do you safely store and transport hazardous materials?
- ✦ What 'hot work' do you do that needs particular care?
- ✦ What can you do to better manage the safety of compressed gasses where used as part of your work?
